Natural Power Demo Data

Report date:
Dec 1, 2020

Type:
Wind Turbine

Natural Power Demo Data - Summary

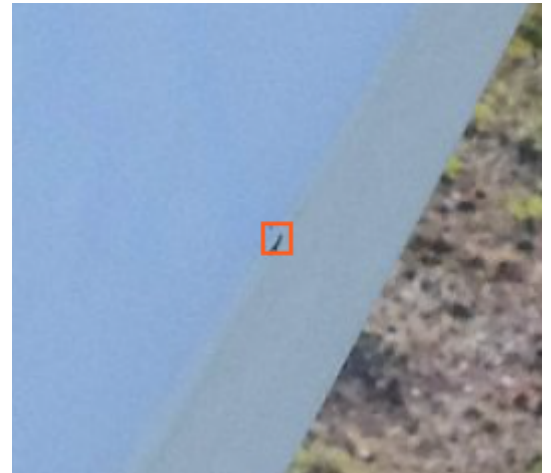
Gel coat chip

0.2m

26mm x 27mm

Chris Rawsley:
Gel coat chip on TE

Repair within 6 months

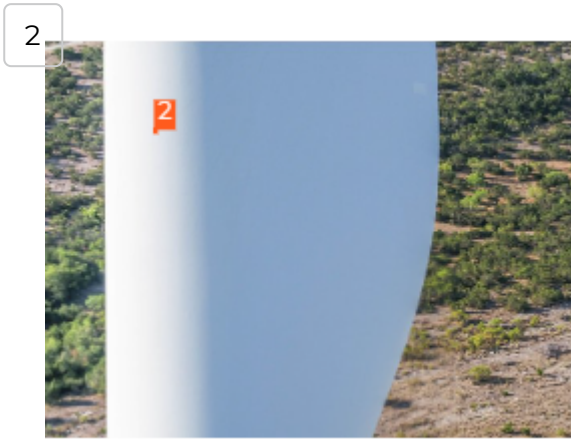
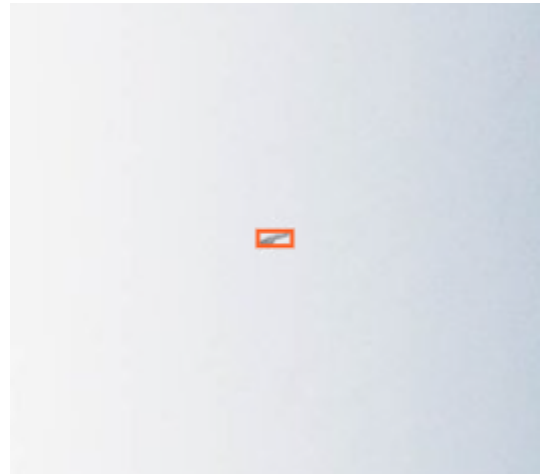
Gel coat chip

0.2m

31mm x 15mm

Chris Rawnsley:
Gel coat chip

Repair within 6 months

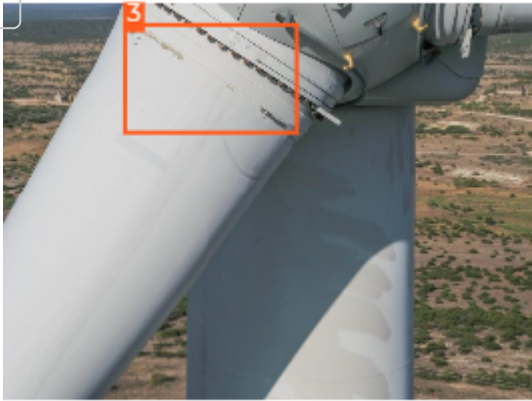
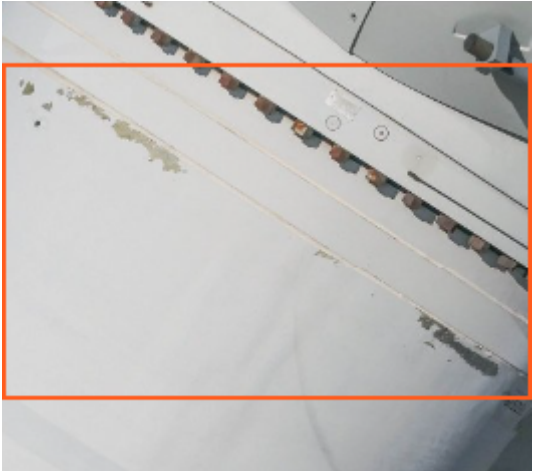
Issue Type: **Damage - Gel Coat** | Severity: 3

Distance from root: **0.1m** | Size: **1785mm x 1139mm**

Chris Rawnsley:
Peeling gel coat on root end with exposed laminate.

Repair within 6 months

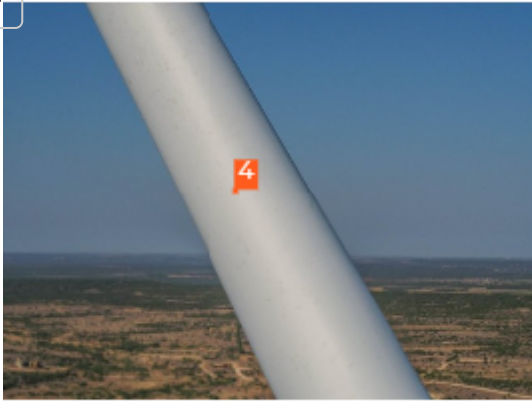
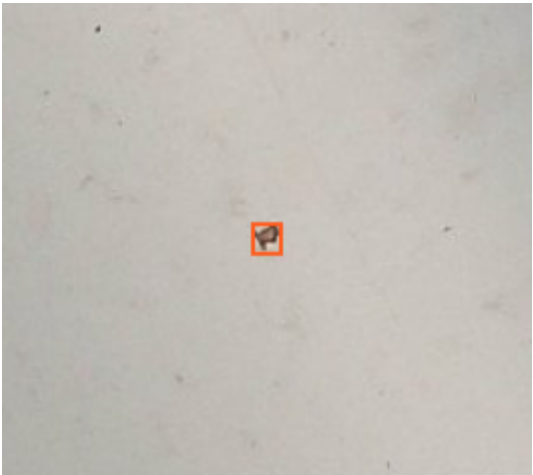
Issue Type: **Gel coat chip** | Severity: 3

Distance from root: **11.2m** | Size: **26mm x 27mm**

Chris Rawnsley:
Large gel coat chip on LE toward the root

Repair within 6 months

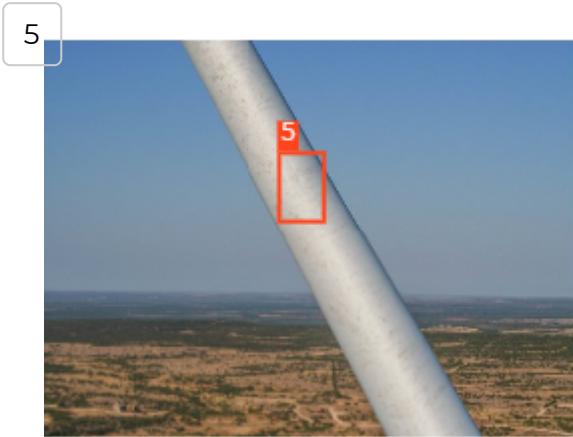
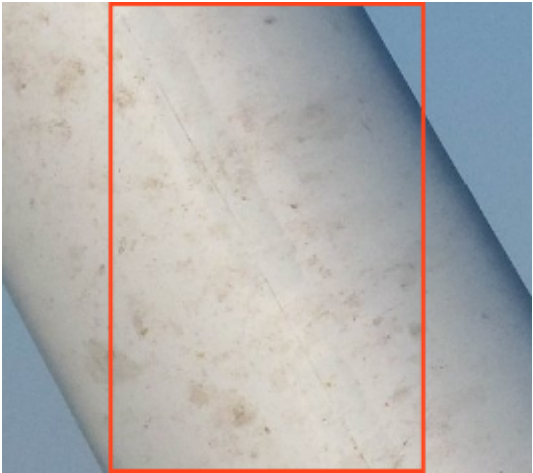
Issue Type: Crack | Severity: 4

Distance from root: 18.8m | Size: 494mm x 739mm

Chris Rawnsley:
Possible failed LE crack repair.

Repair within 3 months

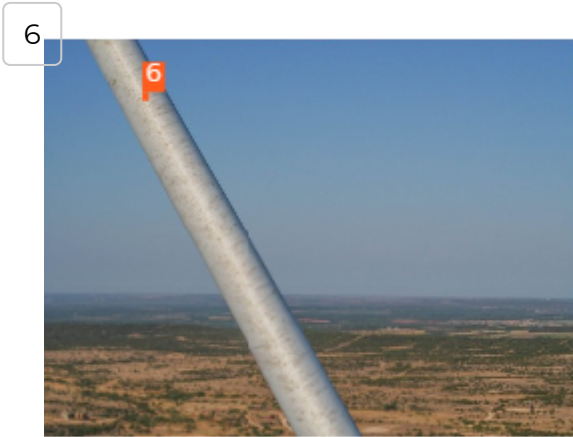
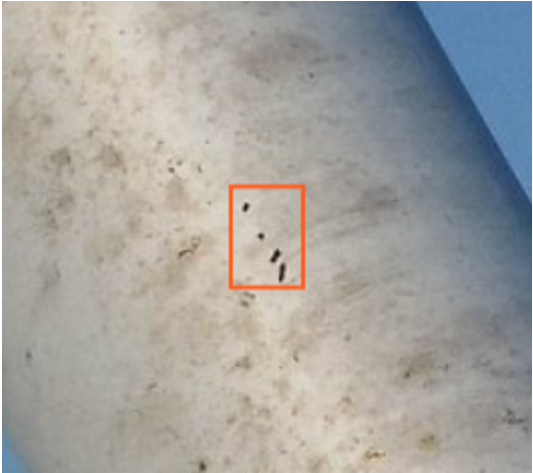
Issue Type: Gel coat chip | Severity: 3

Distance from root: 24.7m | Size: 64mm x 88mm

Chris Rawnsley:
Gel coat chips in LE

Repair within 6 months

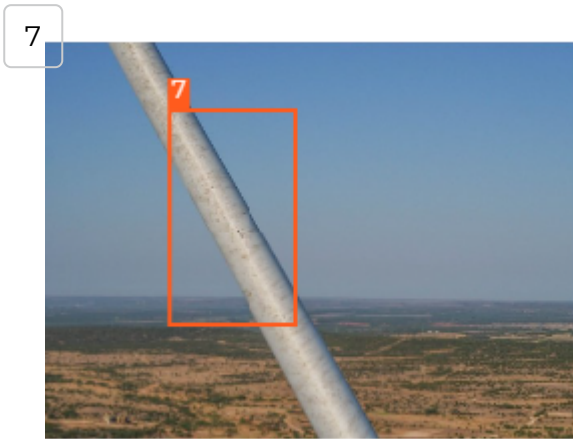
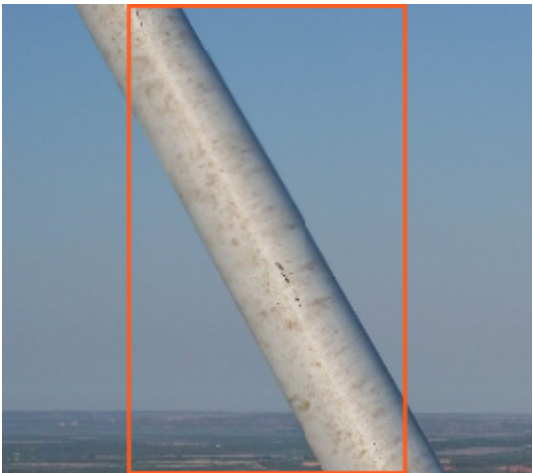
Issue Type: **Gel coat chip** | Severity: 3

Distance from root: **26.4m** | Size: **1318mm x 2227mm**

Chris Rawnsley:
Multiple gel coat damages on LE

Repair within 6 months

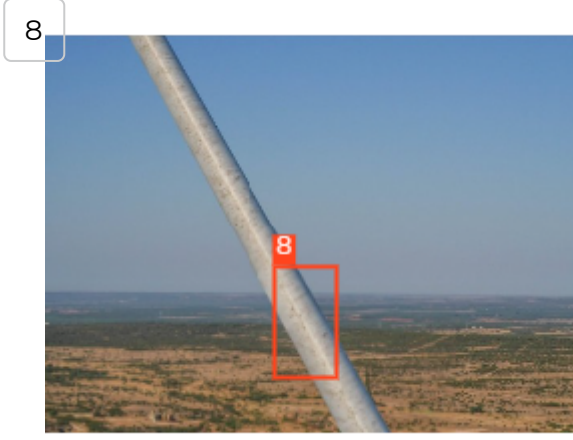
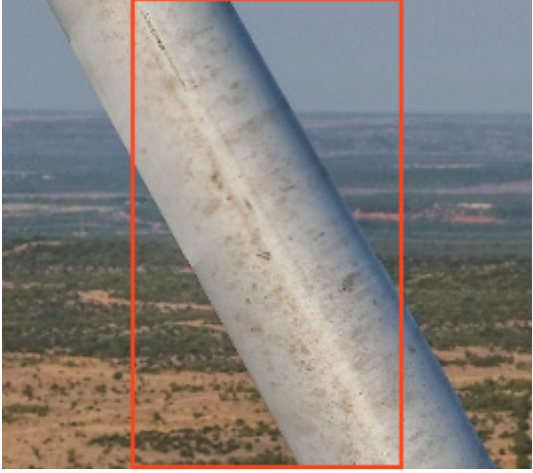
Issue Type: **Crack** | Severity: 4

Distance from root: **29.3m** | Size: **672mm x 1168mm**

Chris Rawnsley:
Area of exposed laminate and LE bondline with possible damage to bond line, also showing a possible LE crack.

Repair within 3 months

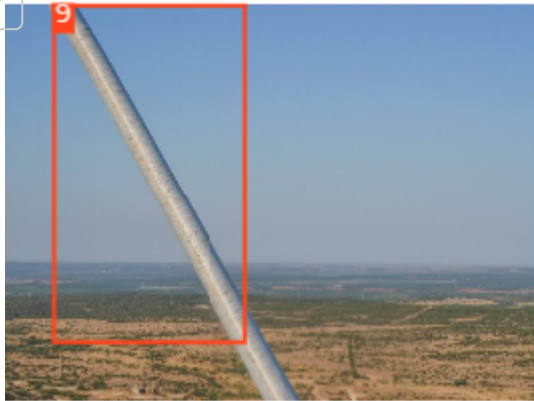
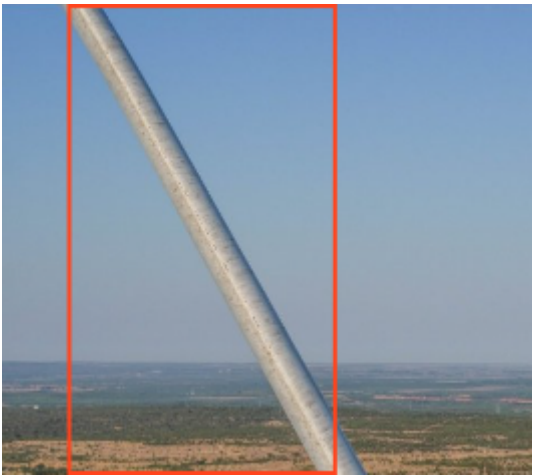
Issue Type: Crack | Severity: 4

Distance from root: 33.8m | Size: 1980mm x 3473mm

Comments: Chris Rawnsley: Further evidence of LE crack, along with multiple gelcoat chips.

Remedy Action: Repair within 3 months

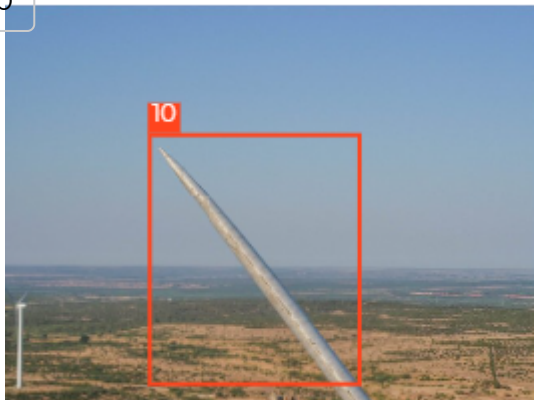
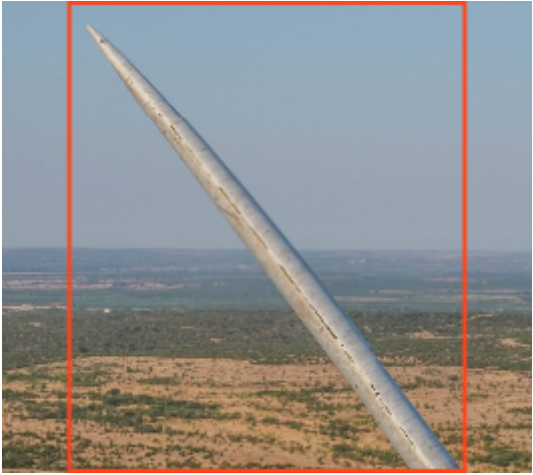
Issue Type: Damage - Gel Coat | Severity: 4

Distance from root: 38.4m | Size: 2174mm x 2575mm

Comments: Chris Rawnsley: Further gelcoat damage along the LE bond line towards the tip, along with damages that carry onto the shell.

Remedy Action: Repair within 3 months

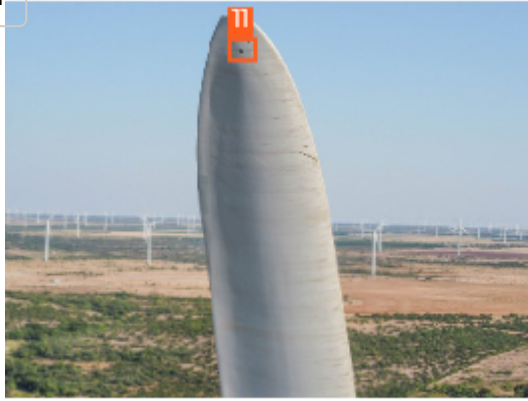
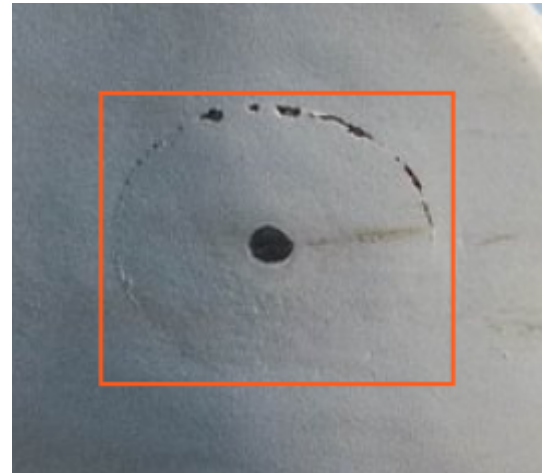
Issue Type: **Damage - Gel Coat** | Severity: 3

Distance from root: **27.7m** | Size: **300mm x 250mm**

Chris Rawnsley:
Gelcoat damage around outer edge of LPS receptor.

Repair within 6 months

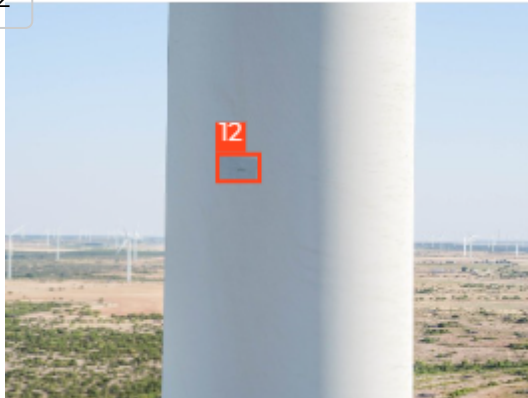
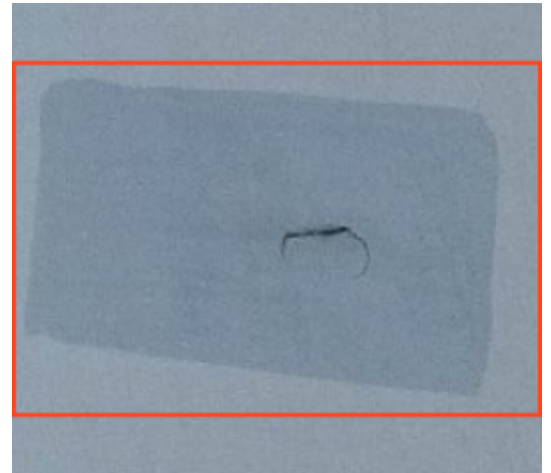
Issue Type: **Crack** | Severity: 4

Distance from root: **12.6m** | Size: **467mm x 314mm**

Chris Rawnsley:
Possible failed repair, crack in shell.

Repair within 3 months

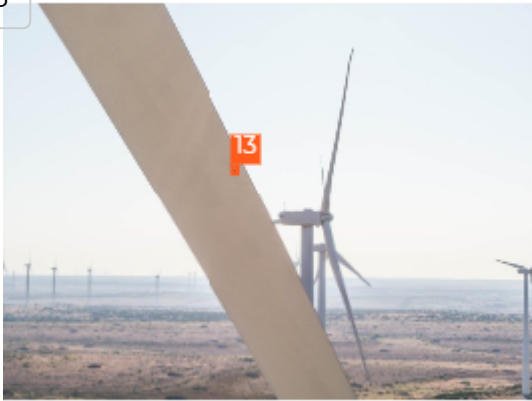
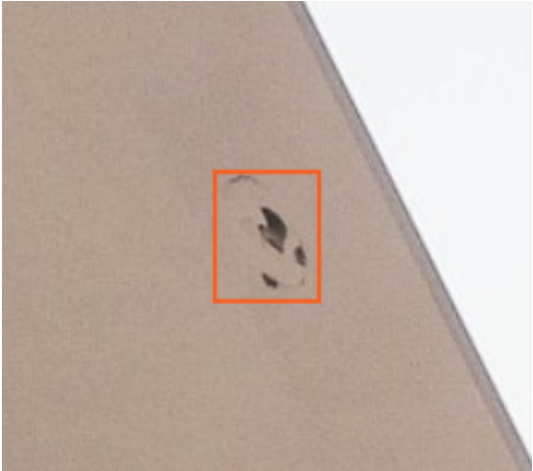
Damage - Gel Coat

28.6m

90mm x 112mm

Chris Rawnsley:
Gecoat on receptor damaged

Repair within 6 months

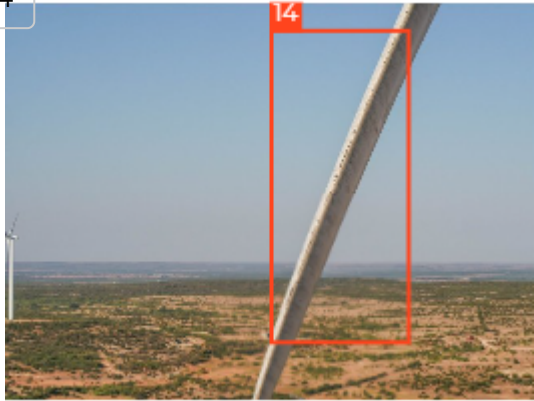
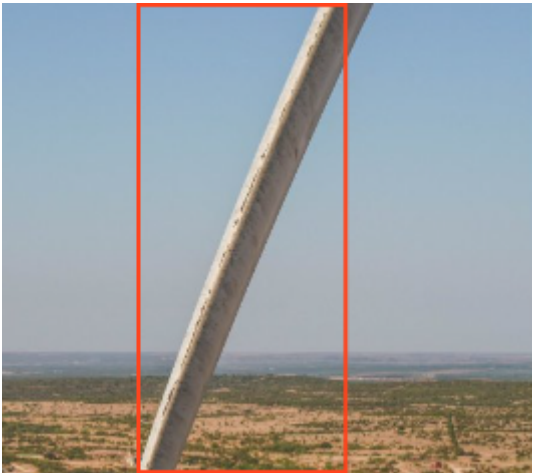
Issue Type: Crack | Severity: 4

Distance from root: 36.0m | Size: 1436mm x 3218mm

Chris Rawnsley:
Large area of LE erosion concentrated on the bond line, Possible crack.

Repair within 3 months

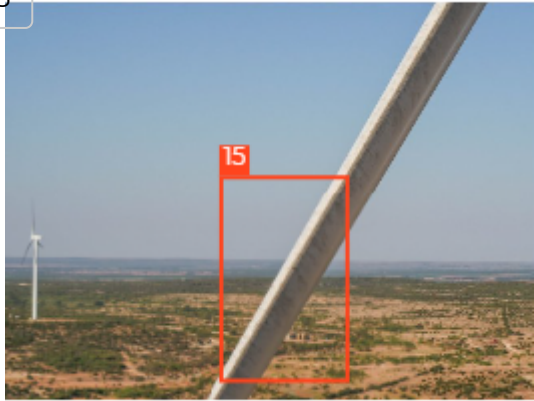
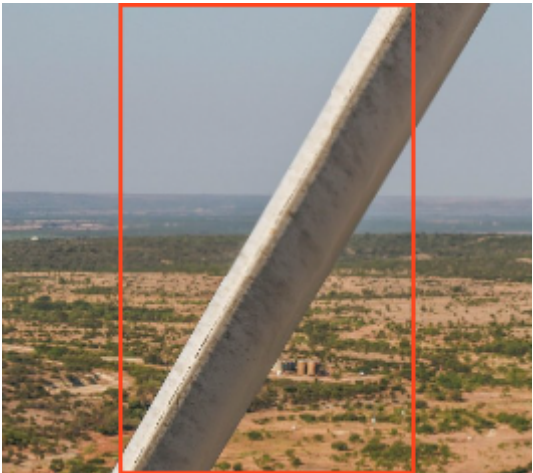
Issue Type: Damage - Gel Coat | Severity: 4

Distance from root: 31.4m | Size: 1323mm x 2111mm

Chris Rawnsley:
Further LE gelcoat damage along bond line.

Repair within 3 months

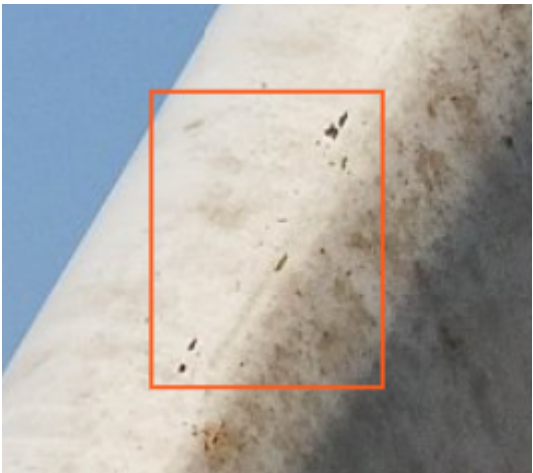
Issue Type: **Gel coat chip** | Severity: 1 2 3 4 5

Distance from root: **27.0m** | Size: **198mm x 254mm**

Chris Rawnsley:
 |Multiple LE gel coat chips.

Repair within 6 months

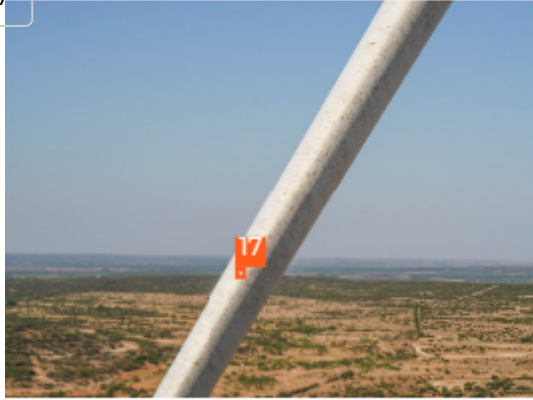
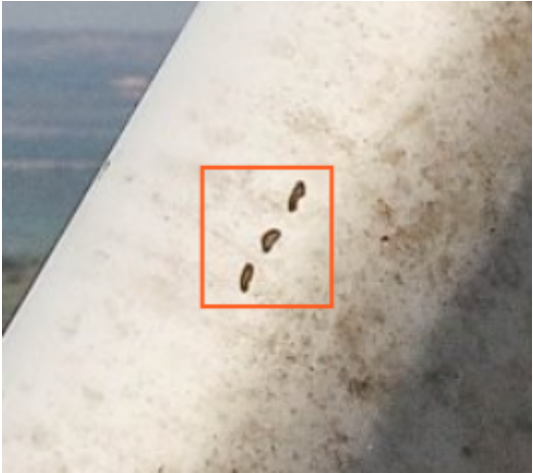
Issue Type: **Gel coat chip** | Severity: 1 2 3 4 5

Distance from root: **22.5m** | Size: **112mm x 120mm**

Chris Rawnsley:
 Multiple large gelcoat chips.

Repair within 6 months

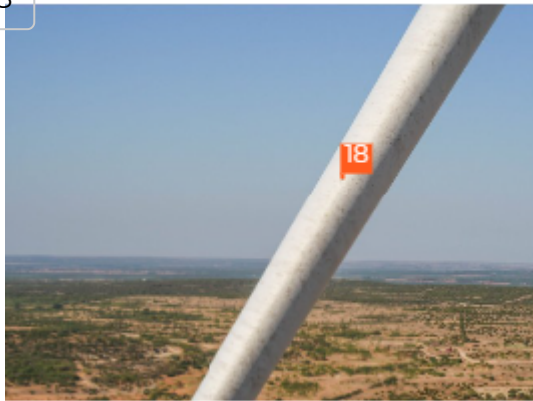
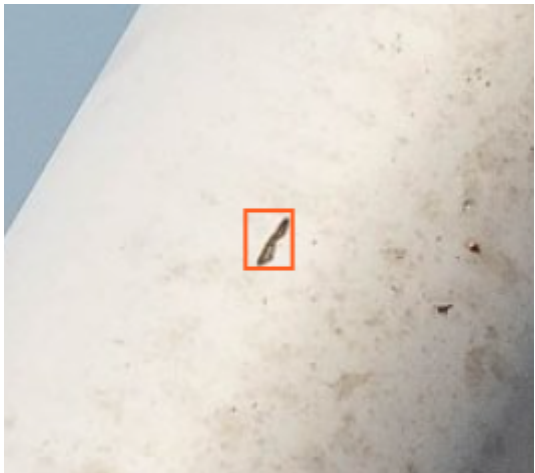
Issue Type: Gel coat chip | Severity: 3

Distance from root: 19.4m | Size: 42mm x 52mm

Chris Rawnsley:
Large gelcoat chip

Repair within 6 months

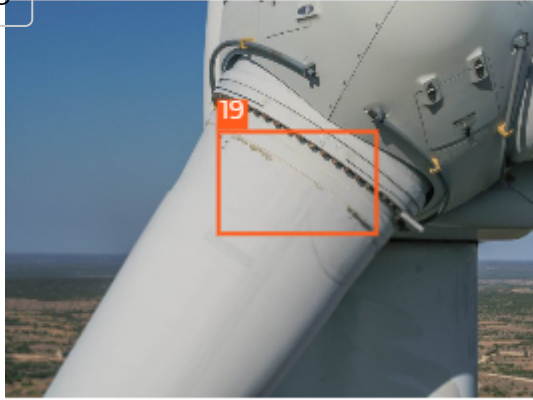
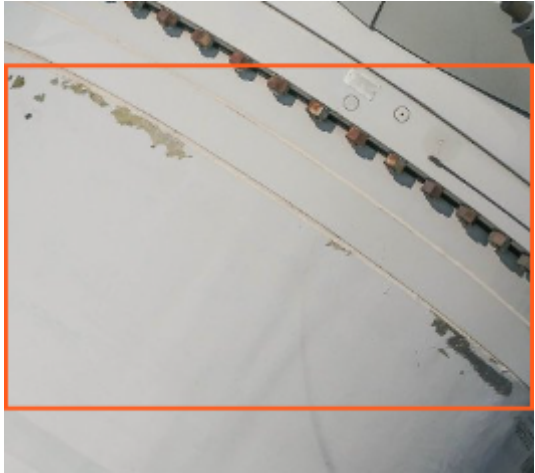
Issue Type: Damage - Gel Coat | Severity: 3

Distance from root: 1.6m | Size: 1646mm x 1079mm

Chris Rawnsley:
Multiple areas of damaged gelcoat around the root, laminate visible.

Repair within 6 months

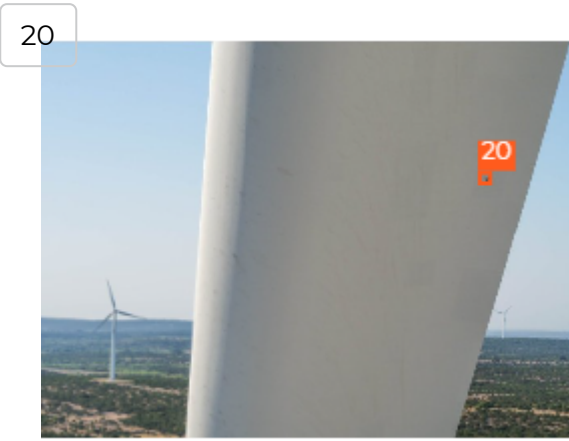
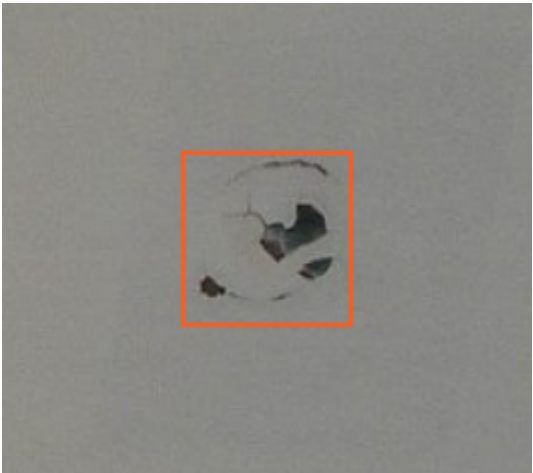
Issue Type: **Damage - Gel Coat** | Severity: **3**

Distance from root: **6.4m** | Size: **144mm x 149mm**

Chris Rawnsley:
Gel coat damaged around LPS receptor

Repair within 6 months

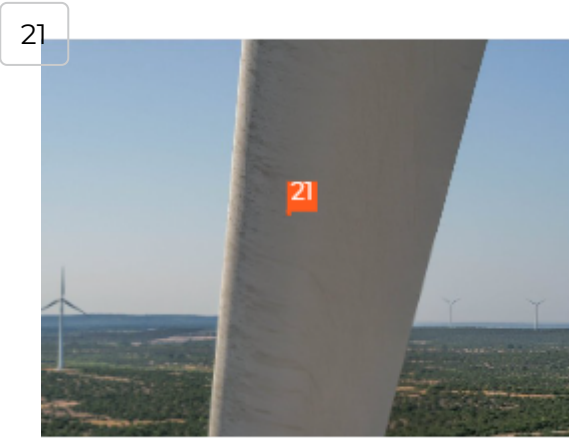
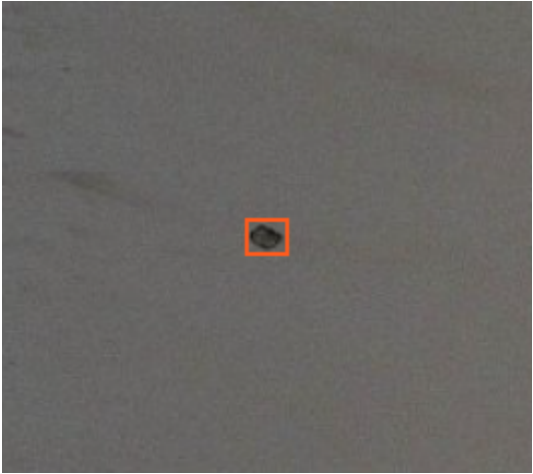
Issue Type: **Gel coat chip** | Severity: **3**

Distance from root: **16.5m** | Size: **36mm x 31mm**

Chris Rawnsley:
Large gelcoat chip on shell.

Repair within 6 months

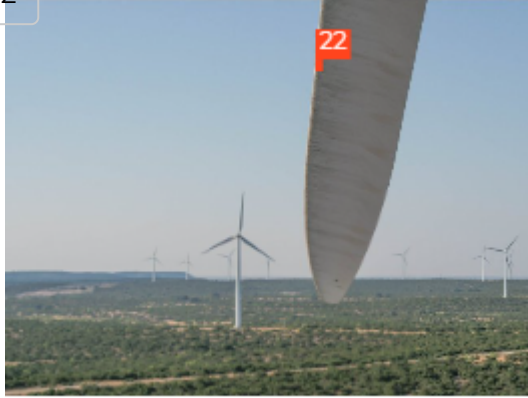
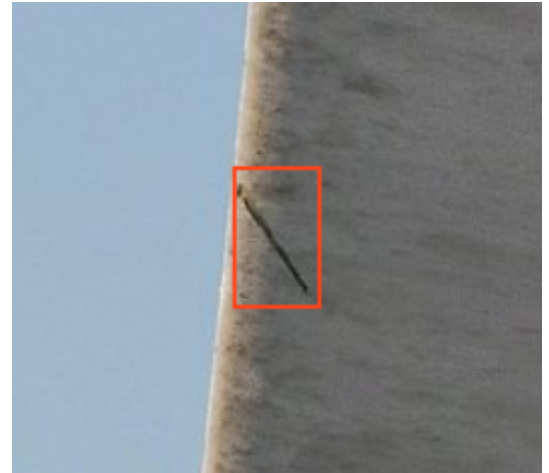
Issue Type: **Damage - Fiber** | Severity: **4**

Distance from root: **32.3m** | Size: **74mm x 120mm**

Chris Rawnsley:
Large chip on LE, possible outer laminate damaged due the the nature of the damage.

Repair within 6 months

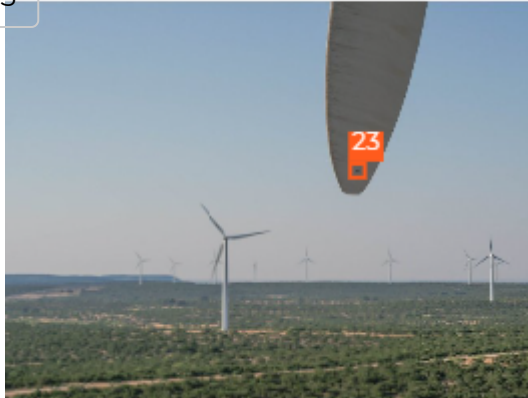
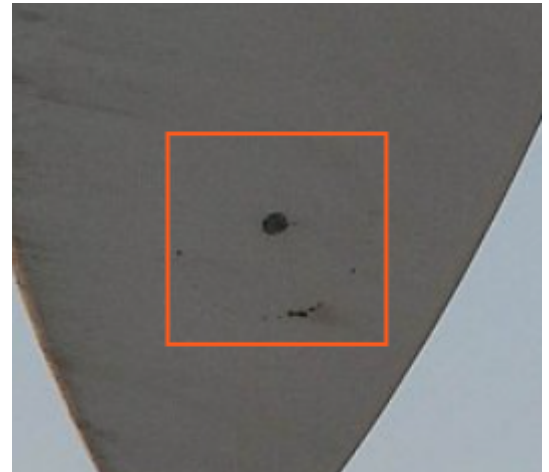
Issue Type: **Gel coat chip** | Severity: **3**

Distance from root: **33.1m** | Size: **187mm x 181mm**

Chris Rawnsley:
Gelcoat chips around LPS tip receptor.

Repair within 6 months

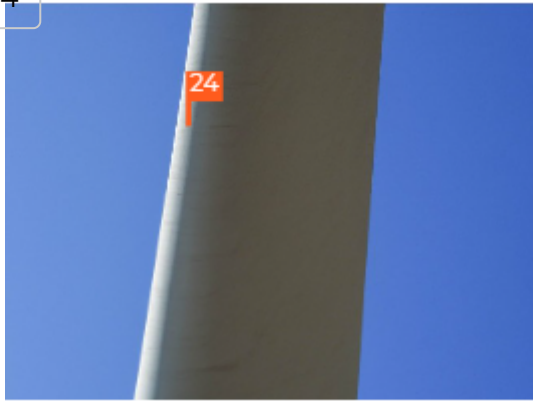
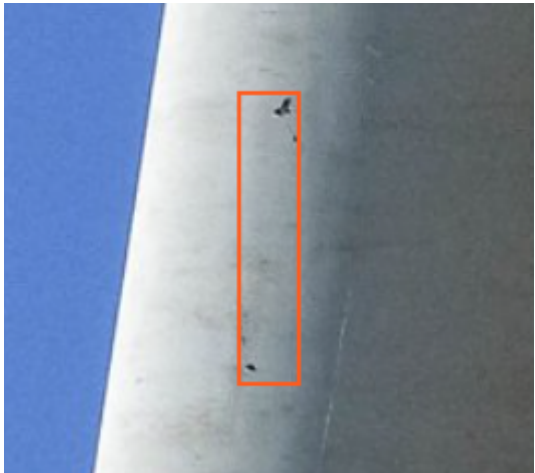
Issue Type: Gel coat chip | Severity: 3

Distance from root: 14.7m | Size: 53mm x 250mm

Comments: Chris Rawnsley: 2x Gelcoat chips | Remedy Action: Repair within 6 months

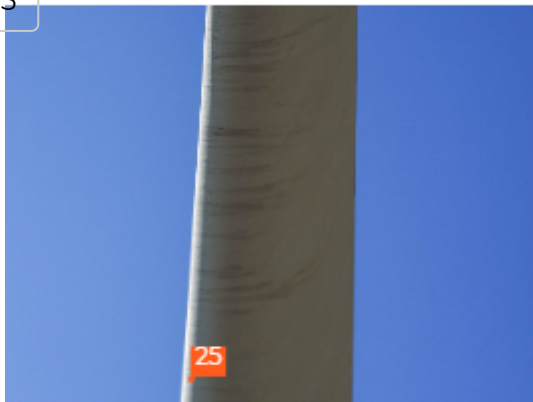
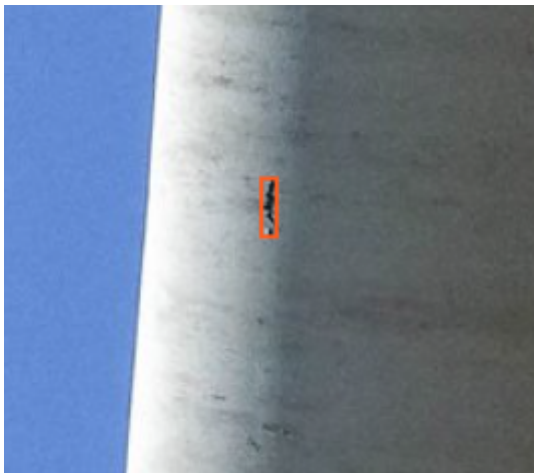
Issue Type: Damage - Gel Coat | Severity: 3

Distance from root: 23.4m | Size: 15mm x 52mm

Comments: Chris Rawnsley: Gelcoat damage on previous repair | Remedy Action: Repair within 6 months

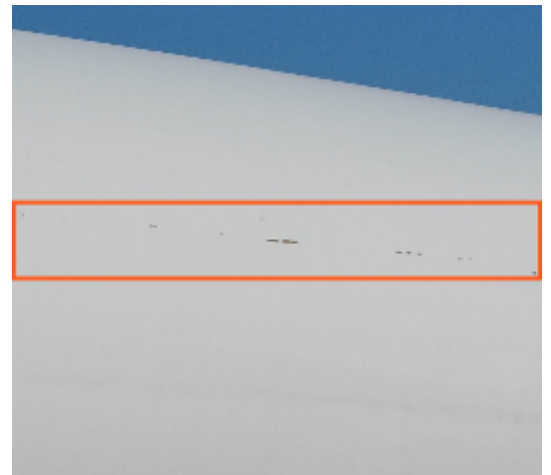
Gel coat chip

0.3m

1468mm x 221mm

Gelcoat chips toward the root, likely air bubbles within the original gelcoat.

Repair within 6 months

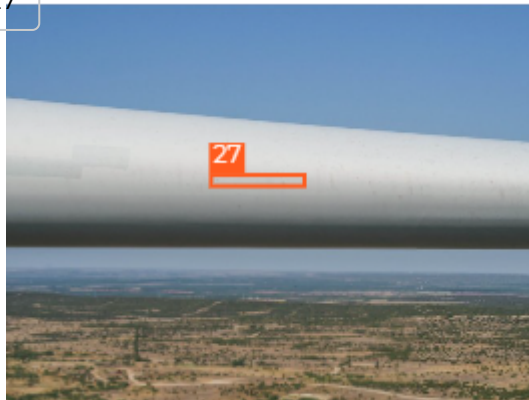
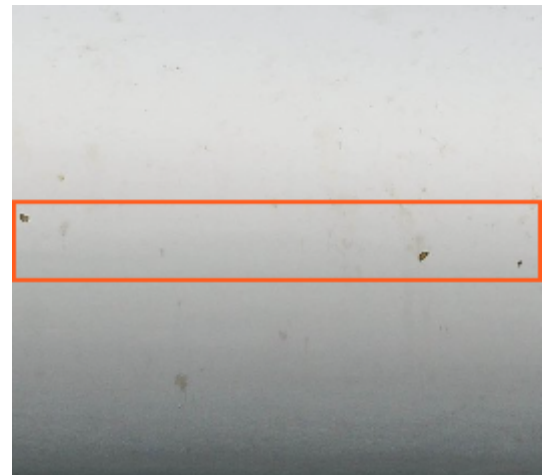
Gel coat chip

7.4m

989mm x 153mm

3x Large gelcoat chips

Repair within 6 months

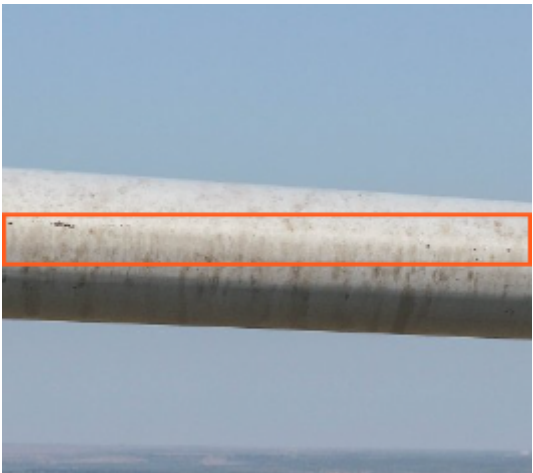
Issue Type: **Gel coat chip** | Severity: 3

Distance from root: **21.0m** | Size: **1754mm x 177mm**

Chris Rawnsley:
Multiple LE gelcoat chips

Repair within 6 months

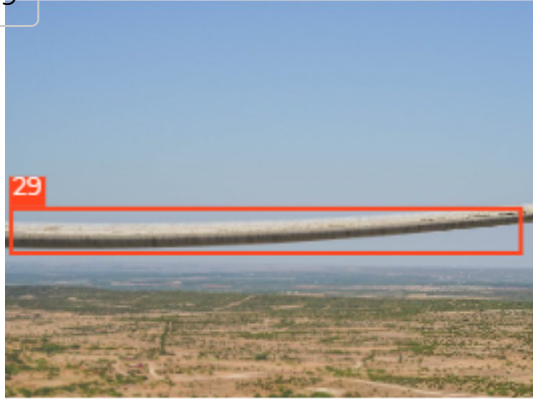
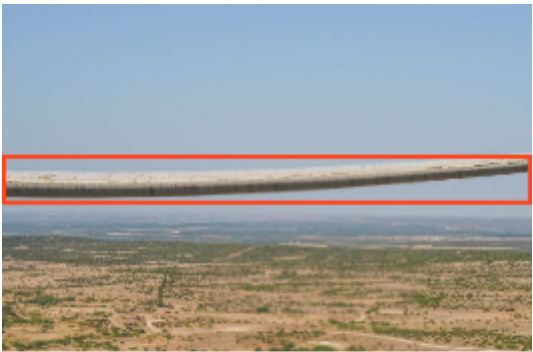
Issue Type: **Damage - Gel Coat** | Severity: 4

Distance from root: **30.6m** | Size: **5225mm x 492mm**

Chris Rawnsley:
Large area of damaged gelcoat along LE bond line with multiple areas of eroded bond line.

Repair within 3 months

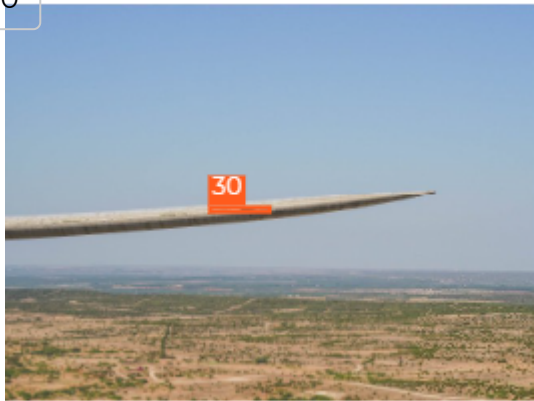
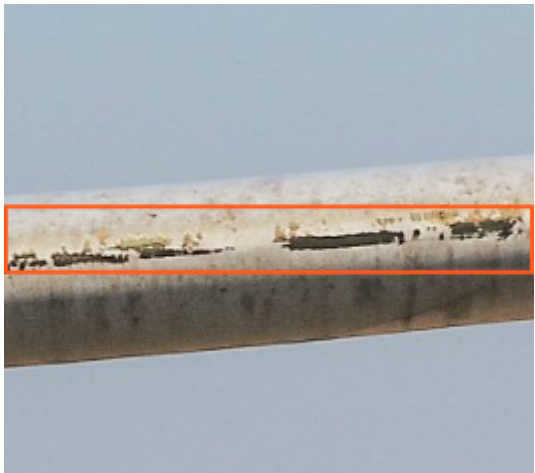
Issue Type: Crack | Severity: 3

Distance from root: 32.0m | Size: 645mm x 84mm

Comments: Chris Rawnsley: Damaged gelcoat and possible crack in LE bondline.

Remedy Action: Repair within 3 months

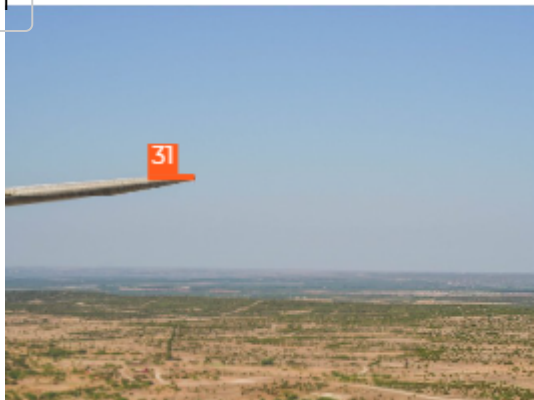
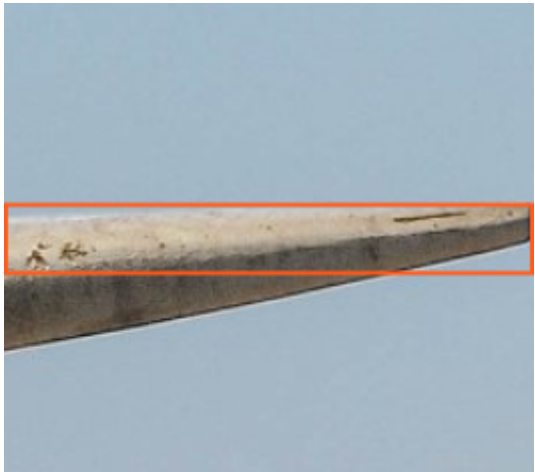
Issue Type: Damage - Gel Coat | Severity: 3

Distance from root: 33.3m | Size: 472mm x 64mm

Comments: Chris Rawnsley: Damaged gelcoat on LE towards the tip

Remedy Action: Repair within 6 months

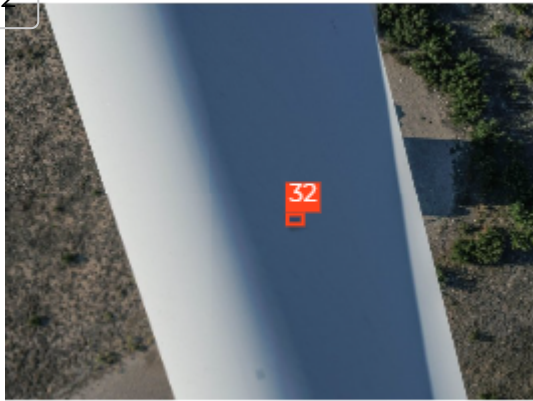
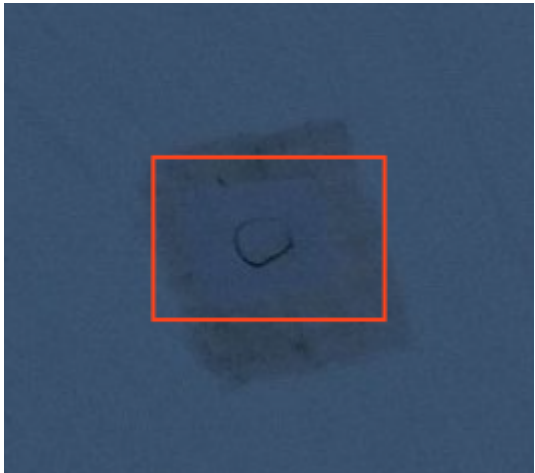
Issue Type: **Damage - Fiber** | Severity: 4

Distance from root: **9.8m** | Size: **198mm x 141mm**

Chris Rawnsley:
Possible failed repair on shell.

Repair within 3 months

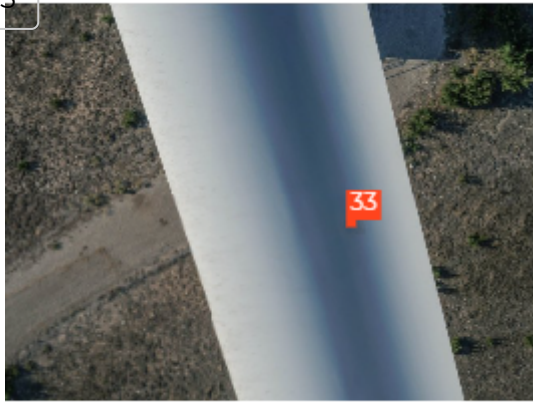
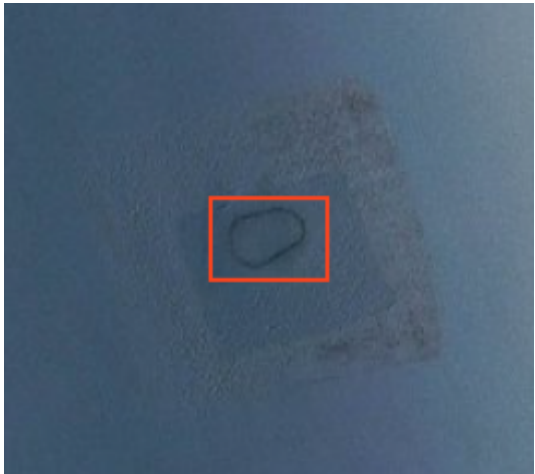
Issue Type: **Damage - Fiber** | Severity: 4

Distance from root: **17.1m** | Size: **101mm x 72mm**

Chris Rawnsley:
Possible failed repair on shell.

Repair within 3 months

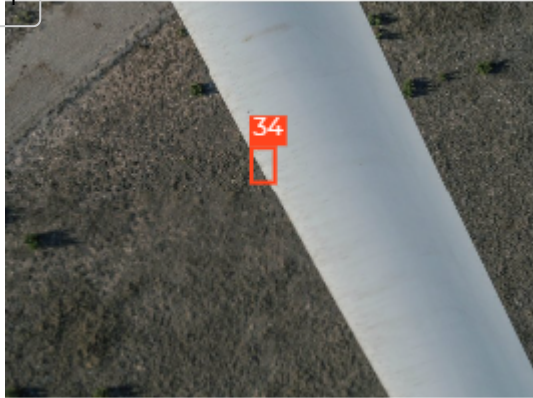
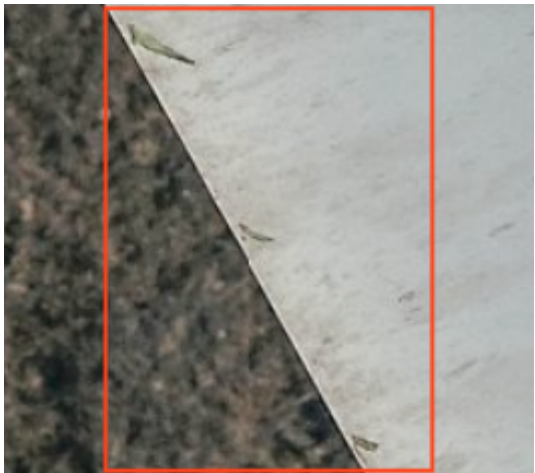
Issue Type: **Damage - Fiber** | Severity: **4**

Distance from root: **27.2m** | Size: **279mm x 395mm**

Chris Rawnsley:
3 x large chips with visible laminate, likely outer laminate damage.

Repair within 3 months

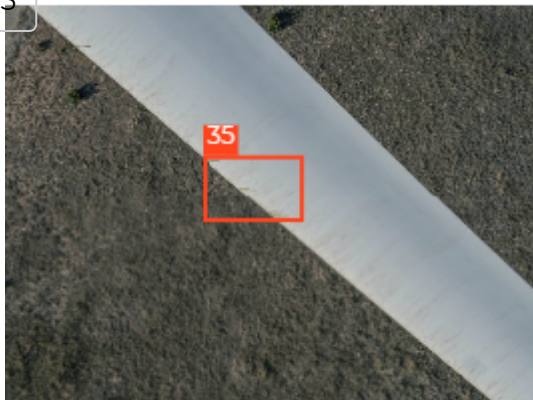
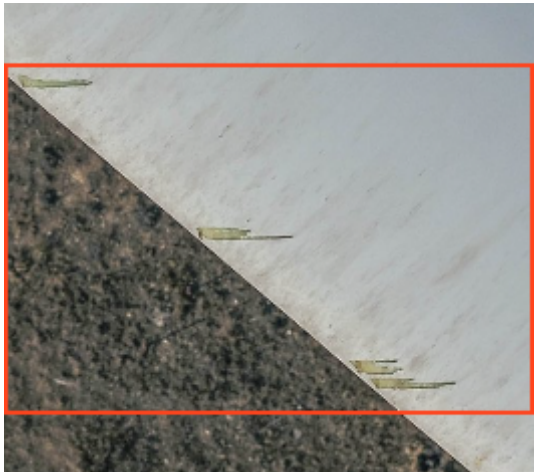
Issue Type: **Damage - Fiber** | Severity: **4**

Distance from root: **30.1m** | Size: **1022mm x 678mm**

Chris Rawnsley:
4 x large chips on LE, with laminate visible. Likely outer laminate damaged.

within 3 months
